Manhole Inspection Summary

Manhole # S33AA_001MH

Location Address: **813 PLOY ST**

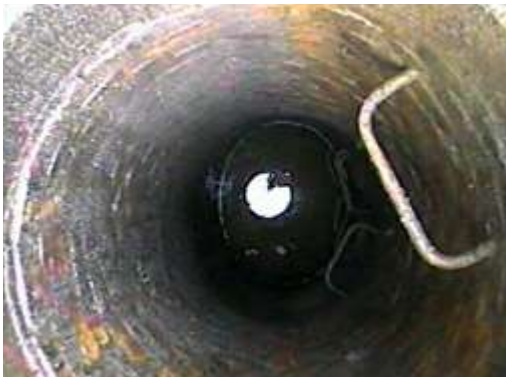
Defect 2

Surcharge ☒ **Evidence Of Surcharge** Depth: **1** (ft.) ☐ Active Surcharge Present

evidence surcharge

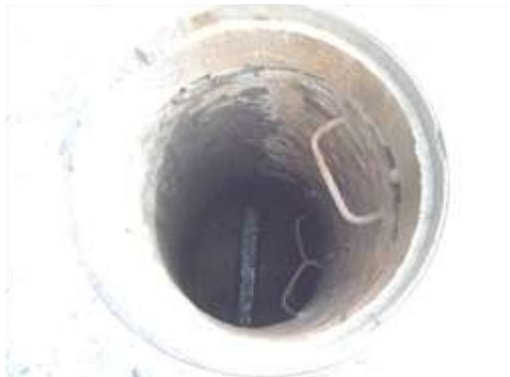
Defect 1

Condition: ☐ Sound ☐ Cracked ☐ Root Intrusion ☒ **Loose Brick** ☒ **Deteriorated**

Steps Count: **9** Missing: **2** ☒ **Corroded**

deteriorated frame offset; corroded step

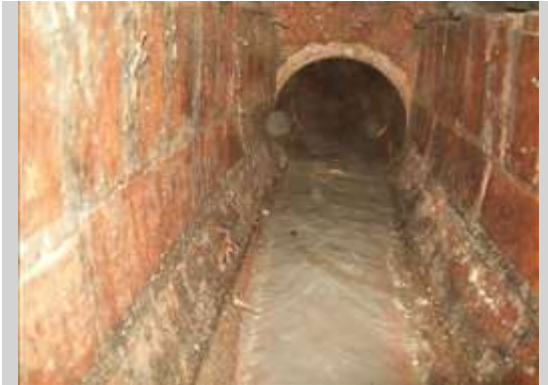
12 O'Clock Outflow

8 in. Circular Gravity Sewer
Pipe Out @ 12 O'Clock

Invert Depth: **14.52** (ft.) Flow Characteristics: **None**

Infiltration: **None** Pipe Seal Cond: **Unknown**

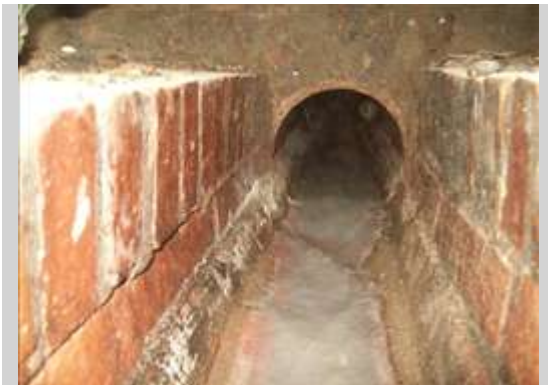
6 O'Clock Inflow

8 in. Circular Gravity Sewer
Pipe In @ 6 O'Clock

Invert Depth: **14.56** (ft.) Flow Characteristics: **None**

Infiltration: **None** Pipe Seal Cond: **Unknown**
